Geophysical and Geotechnical Approaches in investigating causes of road failure along Zone 8 - Crusher Road, Lokoja, Kogi State

Abstract: Roads are an important engineering structure that are crucial in international trade and transportation because they connect cities, states, and nations, respectively. A good number of variables, such as poor construction methods, lack of maintenance, and poor subsurface soil conditions, are major contributors to road instability globally. This study aims to investigate the causes of road failures in Lokoja and its environs, Nigeria. The study employs an integrated approach using 2D Electrical Resistivity Tomography (ERT), Very Low Frequency Electromagnetic (VLF-EM) surveys, sieve analysis, and Atterberg limit tests to investigate the causes of failure along the Zone 8-Crusher road. Eight (8) locations were examined, and soil samples were collected for analysis. The ERT and VLF-EM results revealed three distinct resistivity zones: low, intermediate, and high. The low and intermediate resistivity zones, particularly in the road's failed sections, are likely associated with water-saturated weathered materials. Sieve analysis showed that the percen

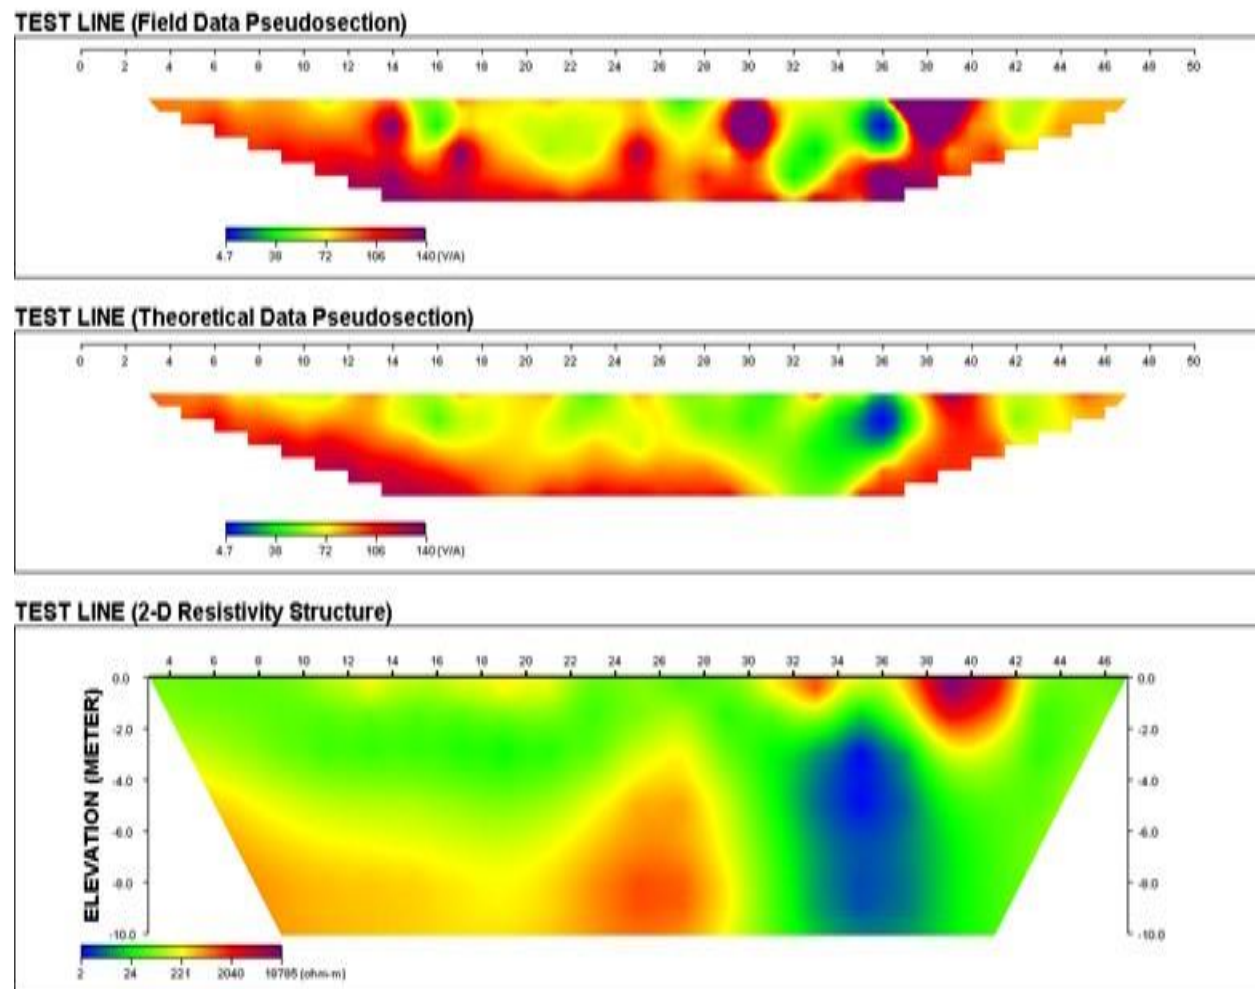
Profile 1 (Fig. 2) has a lateral distance of 0-50 meters with a resistivity ranging from 2-18385 Ωm and a depth of 10 m. The 2-D subsurface resistivity structure shows that at surface distance 0-30m, at a depth of 0-4 m, a zone of low to medium resistivity ranging from 24-221 ohm-meter, indicating probably a weathered basement material consisting of clay or water water-saturated unit. Beneath this zone of low resistivity at surface distance of 0-26m exists an underlying moderate resistivity zone at a depth of 5m to 10m with a resistivity value of 221-250 ohm-meter. At a surface distance of

37-42 meters a high resistivity unit greater than 2040 ohm-meter exists down to a depth of 3m, indicating probable **fresh basement**. At surface distance 34-36m at depth 2-10 m exists a very low resistivity zone less than 24 ohms, which may be a result of water saturation and this may cause road failure.

Fig. 2: 2D Resistivity for Profile 1 (Failed Segment) showing resistivity variation across the entire profile line

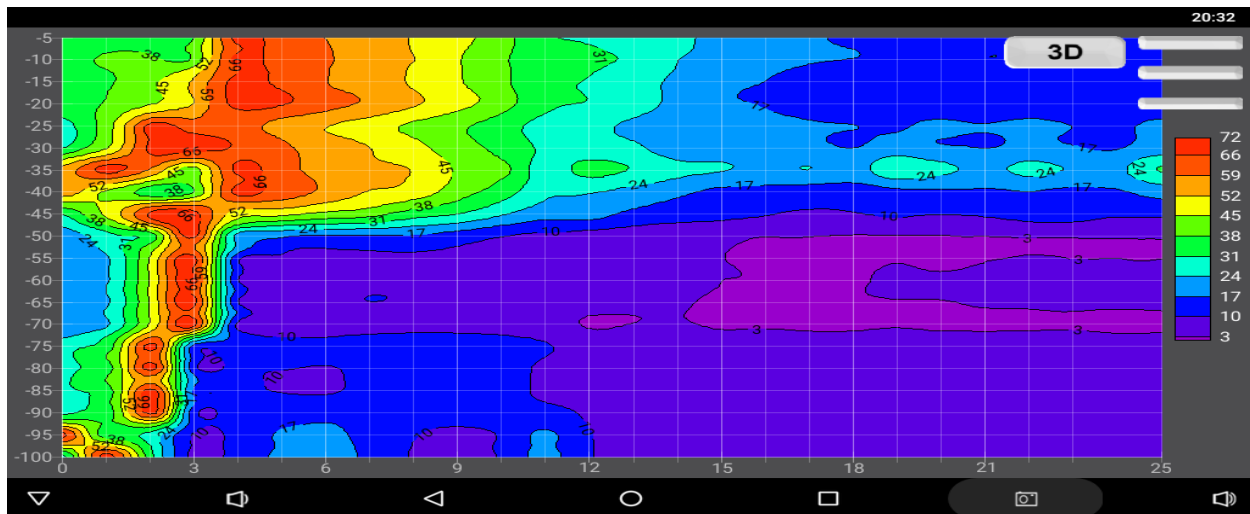
VLF-EM profile (Fig. 3) showed that at profile line 2-9 exist a high resistivity zone exists from a depth of 5-40 m; this may be a zone of high resistivity material such as lateritic soil. At profile line 12-25, from a depth of 5-100 m is a low resistivity zone probably as a result of weathered basement or water saturated zone, which may result to road failure.

Fig. 3: VLF-EM Profile 1 (Failed Segment) showing variation in resistivity

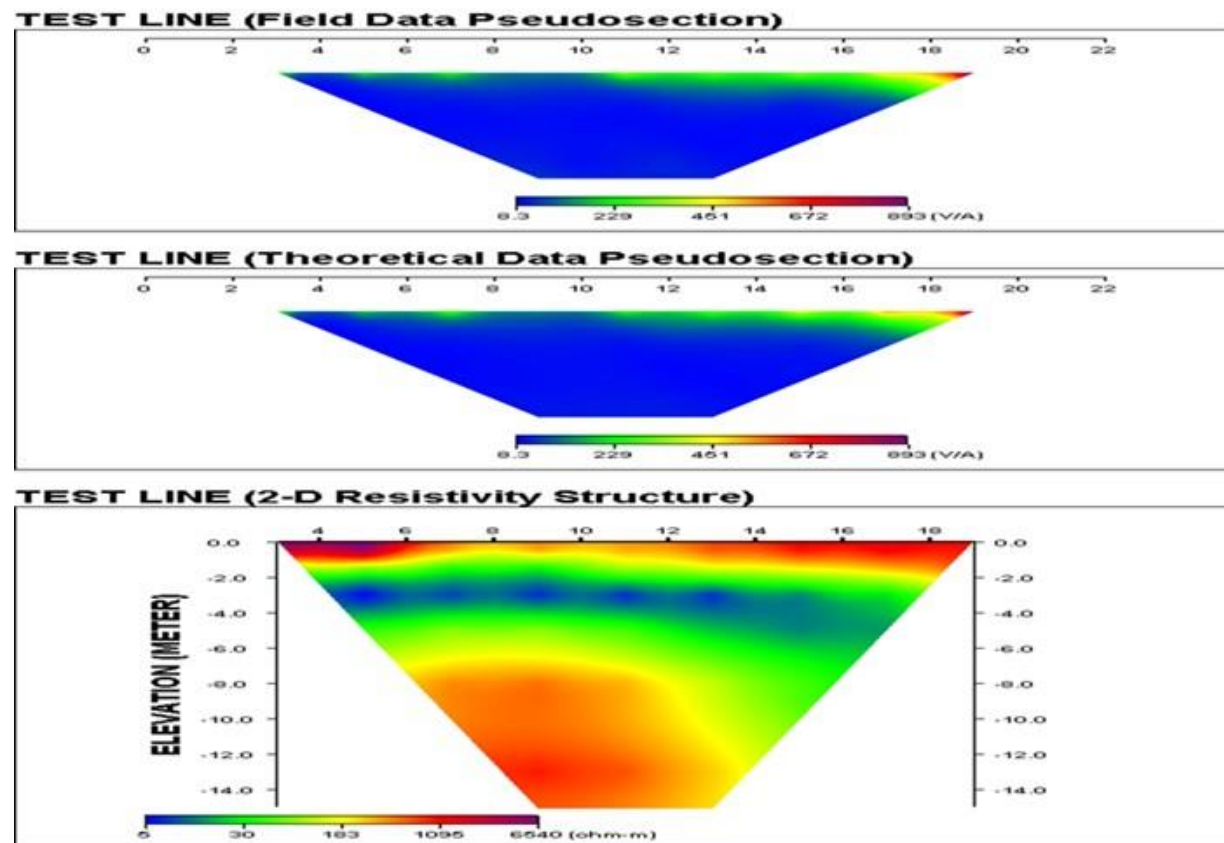
6540 Ω m and with a profile length of 0-18m. High resistivity value of about 6540 Ω m is seen at the top layer along the entire profile length, having a shallow depth of about 0-1.8m, this layer may represent the lateritic clay. Below is a moderate resistivity layer with a value of 30-183 Ω m, this layer has a lateral distance of 0-18 m and also a depth of 1.8-9m. A low resistivity layer with a resistivity value of less than 20 Ω m lying within this moderate resistivity layer mentioned earlier at a lateral distance of 0-18 meters with a thickness of about 1.5m, this layer is probably clay as a result of basement weathering or water water-saturated unit, which might lead to road failure. At a depth of 9-15 m extending to a lateral distance of 0-14m, there is a zone of high resistivity of 183-6540 Ω m, which also seems to be a competent zone at depth.

Fig. 10: 2D Resistivity for Profile 5 (Failed Segment) showing resistivity variation across the entire profile length

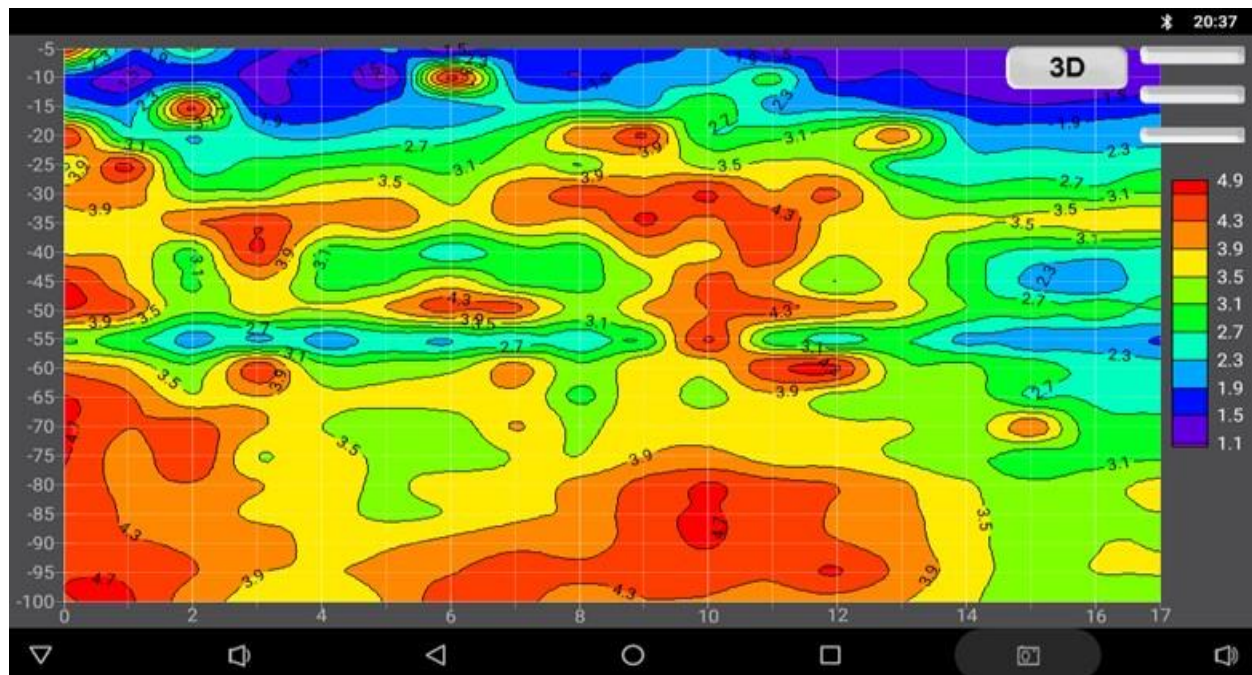
The VLF-EM Graph of profile 5 (Fig 11) has resistivity variation across the profile. Corresponding to the 2D resistivity image of the profile (Fig. 10) at 5 m depth, exist zone of low resistivity (blue colour) indicating a zone of fracture or water-saturated zone, which may cause instability of the road segment. A moderate resistivity layer (green colour) exists below the low resistivity layer at a depth of 15-20 m. At deeper depth of 25-100m exist high resistivity zones (red colour) indicating stable basement rock.

Fig. 11: VLF-EM Graph profile 5(Failed Segment) showing variation in resistivity across the entire profile line

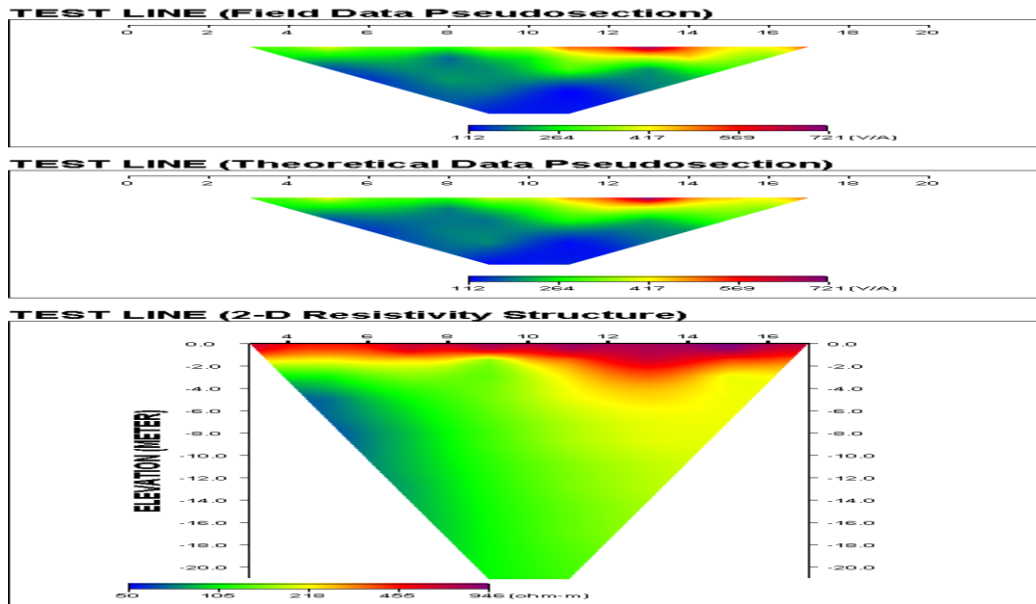
Underlying the zone of high resistivity is a moderately resistivity zone from a lateral distance of 0-16m at a depth of 2-20m with resistivity values ranging from about 105-218 Ωm . Below the moderate resistivity zone, at a lateral distance of 4-6m at a depth of 4-12 m, exists a low resistivity zone of below 70 Ωm , which may be a clayey zone or water saturated zone and may cause road instability, especially when the road is plied by heavy trucks.

Fig. 12: 2D Resistivity for Profile 6 (Failed Segment) showing resistivity variation across the entire profile length

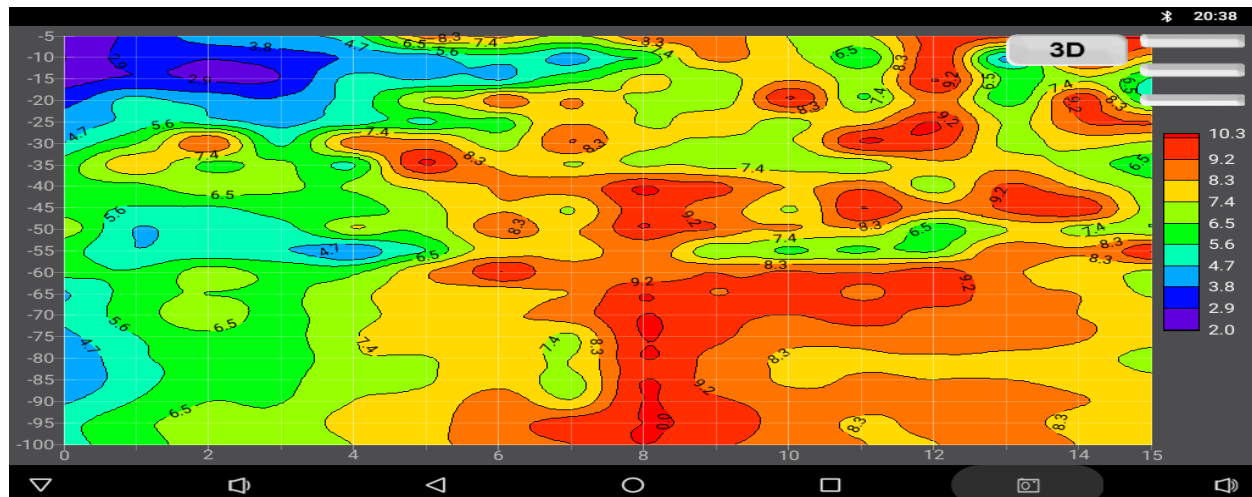
The VLF-EM result for profile 6 (Fig. 13) showed resistivity variation. The result revealed a moderate to high resistivity zone (green to red colour) at a depth of 5-100m. At line 0-2 at a depth of 5-25 m, there is a low resistivity zone (blue colour), possibly a fracture or water saturated zone corresponding to the low resistivity zone of the 2D resistivity image of the same profile (Fig.12) at the same depth.

Fig. 13: VLF-EM Graph profile 6 (Failed Segment) showing variation in resistivity across the entire profile line

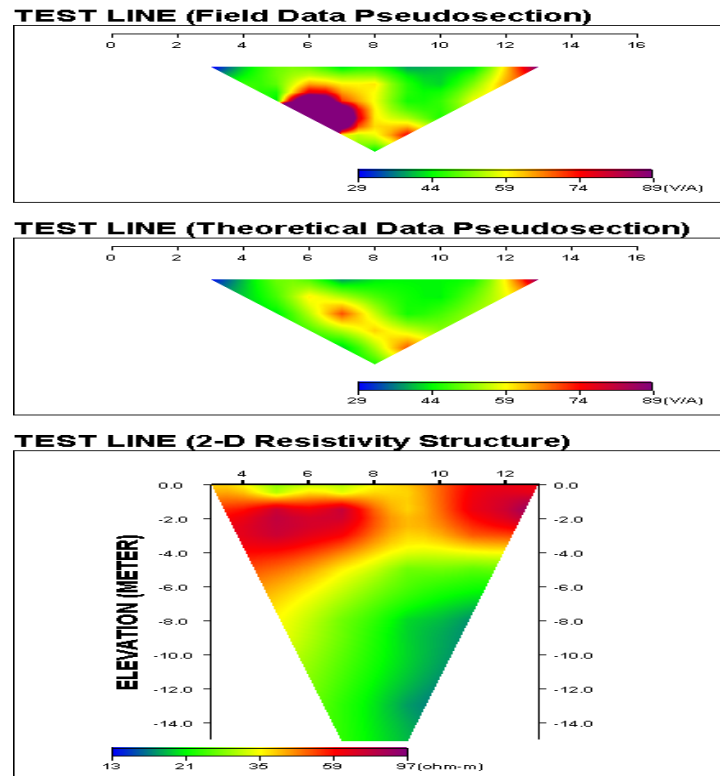
The profile length and resistivity of the 2D resistivity profile 7 are 0-14m (Fig. 14) and 13-97 Ω m, respectively. At surface distance 0-14m

there is high resistivity zone of about 35-97 Ω m extending down to a depth of 8m, this zone is probably a zone of lateritic clay.

Fig. 14: 2D Resistivity for Profile 7(Stable Segment) showing resistivity variation across the entire profile length

At a depth of 8-14m, there is a medium resistivity zone of about 21-35 Ωm . This zone extends laterally a surface distance of 0-10 m. Towards the edge of this profile at the right-hand side, there is a low resistivity zone of less than 15 Ωm at a lateral distance of 11-14 m, which could be a zone of weathered basement rock or water water-saturated zone.

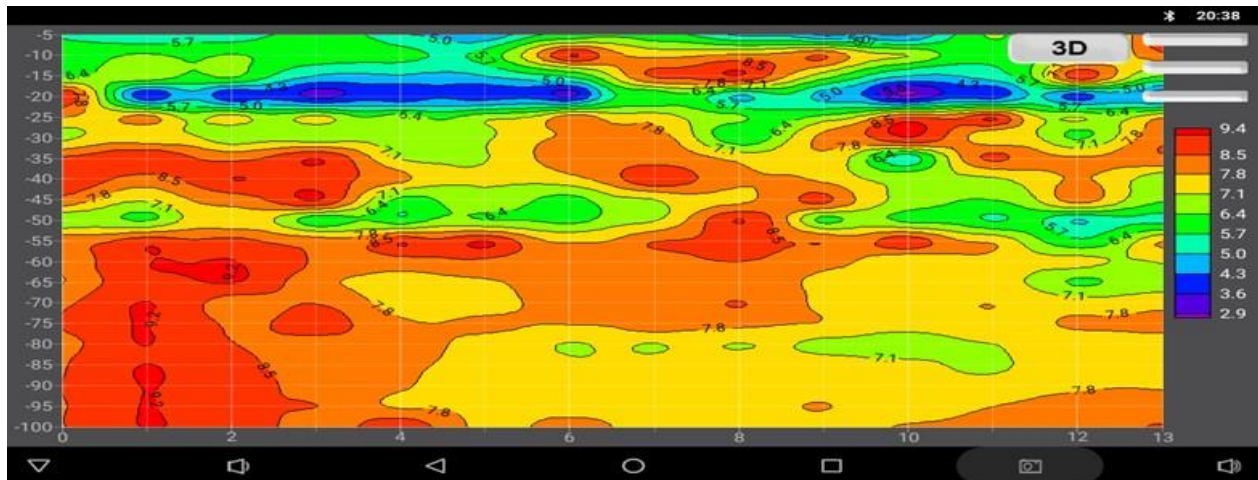
The VLF-EM result for profile 7 (Fig.15) showed that the resistivity value. The result

revealed a moderate resistivity zone (green colour) at a depth of 5-15 m. At a depth of 16-20 m, there is a low resistivity zone (blue colour) and this zone is seen at line 1-13. This is probably a fracture or water-saturated zone and can possibly contribute to pavement failure. Below this zone lies zones of medium to high resistivity (green to red colour) to a depth of 100 m. This can represent an electric basement with stability.

Fig. 15: VLF-EM Graph profile 7(Stable Segment) showing variation in resistivity across the entire profile line

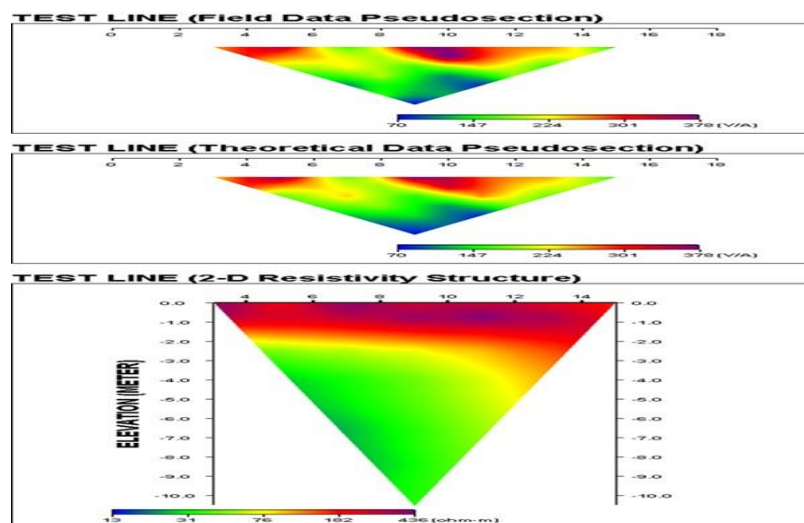
The resistivity and profile length of the 2D resistivity profile 8 is 13-436 Ω m and 0-16m, respectively (Fig. 16). At a surface distance of 0-16m at a depth of 0-2 m there is a high resistivity zone of about 76-436 Ω m and this is a zone of lateritic clay. Underlying this zone of high resistivity lies a zone of medium resistivity and extends down from a depth of 2 to 10m. There is a low resistivity zone that also occurs at the extreme left of the profile, showing a resistivity value of less than 22 Ω m,

this could probably be a zone of weathered basement or water water-saturated zone.

Fig. 16: 2D Resistivity for Profile 8 (Failed Segment) showing resistivity variation across the entire profile length

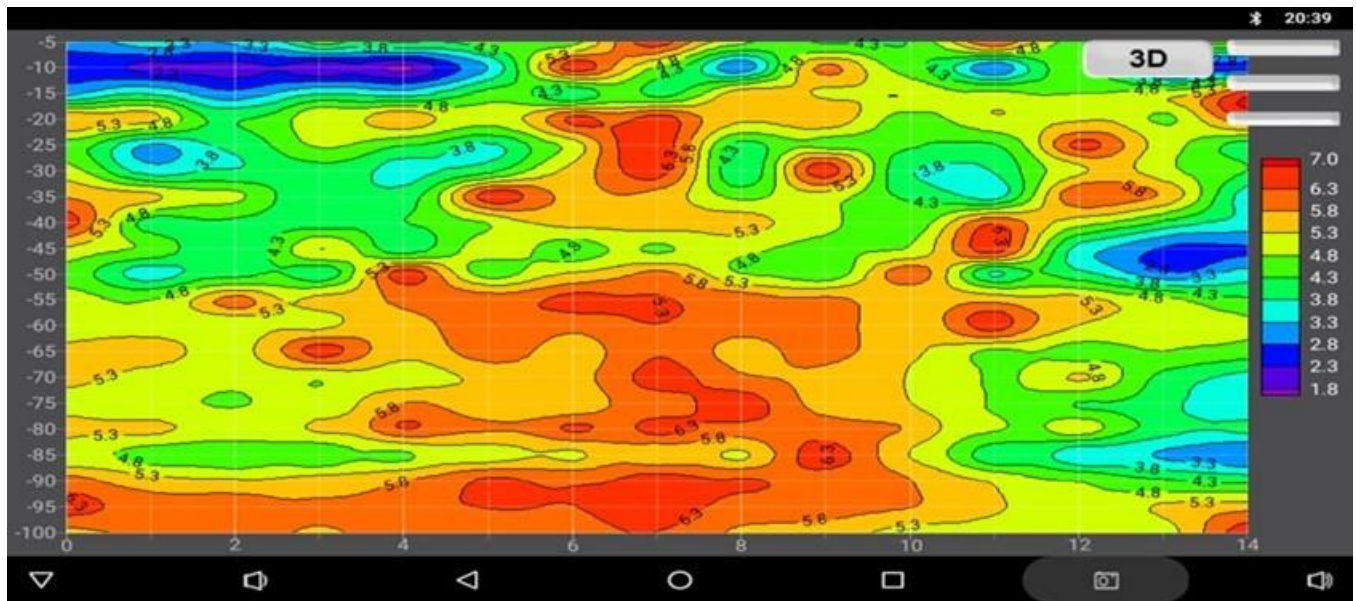
The VLF-EM result for profile 8 (Fig.17) showed the resistivity value. The result revealed a low resistivity zone (blue colour) at depth 5-10m from line 0-5 corresponding to the low resistivity zone on the 2D profile.

This zone could be as a result of fracture or water saturated zone. Below this zone lies zone of moderate to high resistivity (green to red colour) The VLF-EM result corresponds to the result of the 2D resistivity result.

Fig. 17: VLF-EM Graph profile 8 (Failed Segment) showing variation in resistivity across the entire profile line

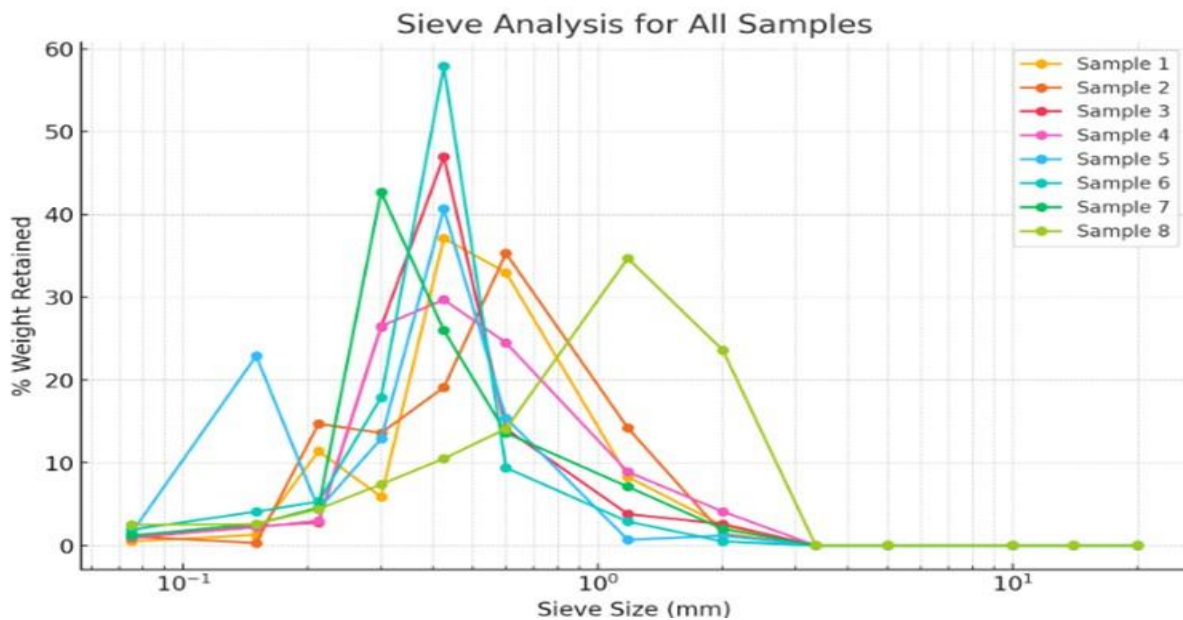
Fig 18: Graphical representation of particle distribution curve for Samples 1 to 8

Especially if the clay is rich in montmorillonite mineral. Most of the samples exhibited significant amounts of medium to fine sand, indicating that the soils are primarily sandy in nature. The absence of excessive fines suggests that the soil will likely have good drainage characteristics, which is essential for preventing water accumulation in the subgrade. This aligns with previous research showing that well-draining soils are less prone to retaining moisture, thereby reducing the risk of weakening the road base (Amadi *et al.*, 2015). Therefore, the sieve analysis suggests that the
